PRESSURE EQUIPMENT ENGINEERING SERVICES, INC.

FINITE ELEMENTS ANALYSIS OF COMPRESSOR CAP

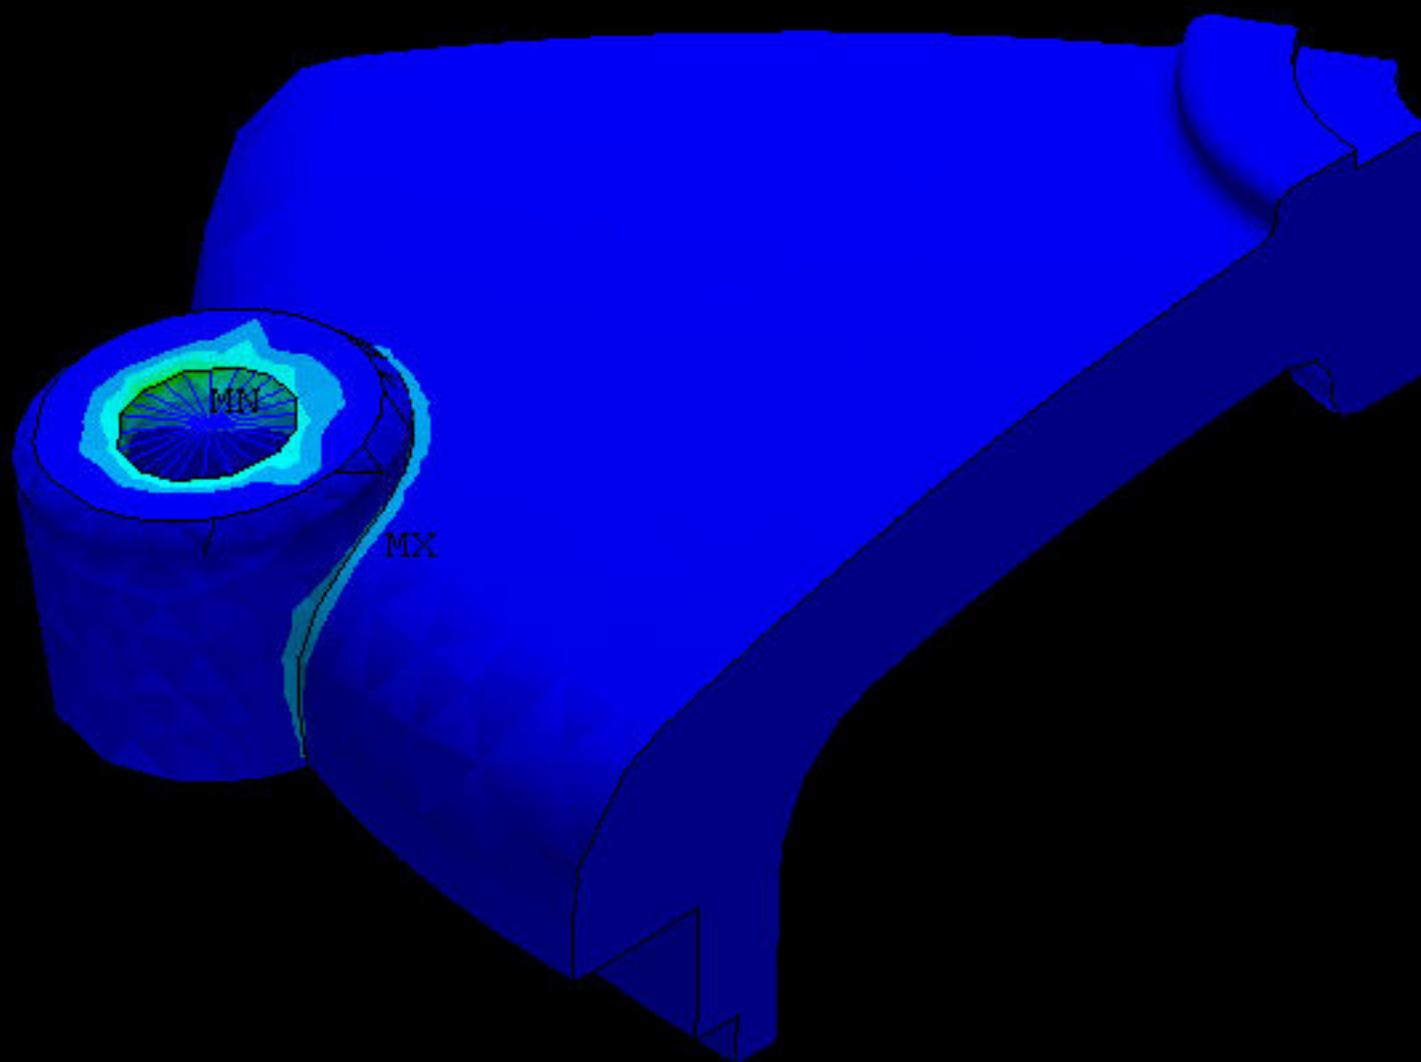
The exact material specification for the compressor cap was not known. Hence, the measured value of tensile strength was used for calculation purposes. From the results of the analysis, it was found that the stresses in the dished portion of the cap were well within allowable stress levels. However, the localized high stresses (beyond the measured tensile strength of the material) in the cast iron cap near the center jack bolt and the near the cap bolts located at the perimeter were causing the failure of the compressor cap.

NODAL SOLUTION

SEQV (AVG)

SMX =119258

A re-design using cast steel (e.g. SA-216 Grade WCB or Grade WCC) with the current cap dimensions led to acceptable stress levels in the compressor cap. Based on the above analysis, it was recommended to replace the compressor cap material from cast iron to cast steel.
