PRESSURE EQUIPMENT ENGINEERING SERVICES, INC.

FINITE ELEMENTS ANALYSIS OF COMPRESSOR CAP

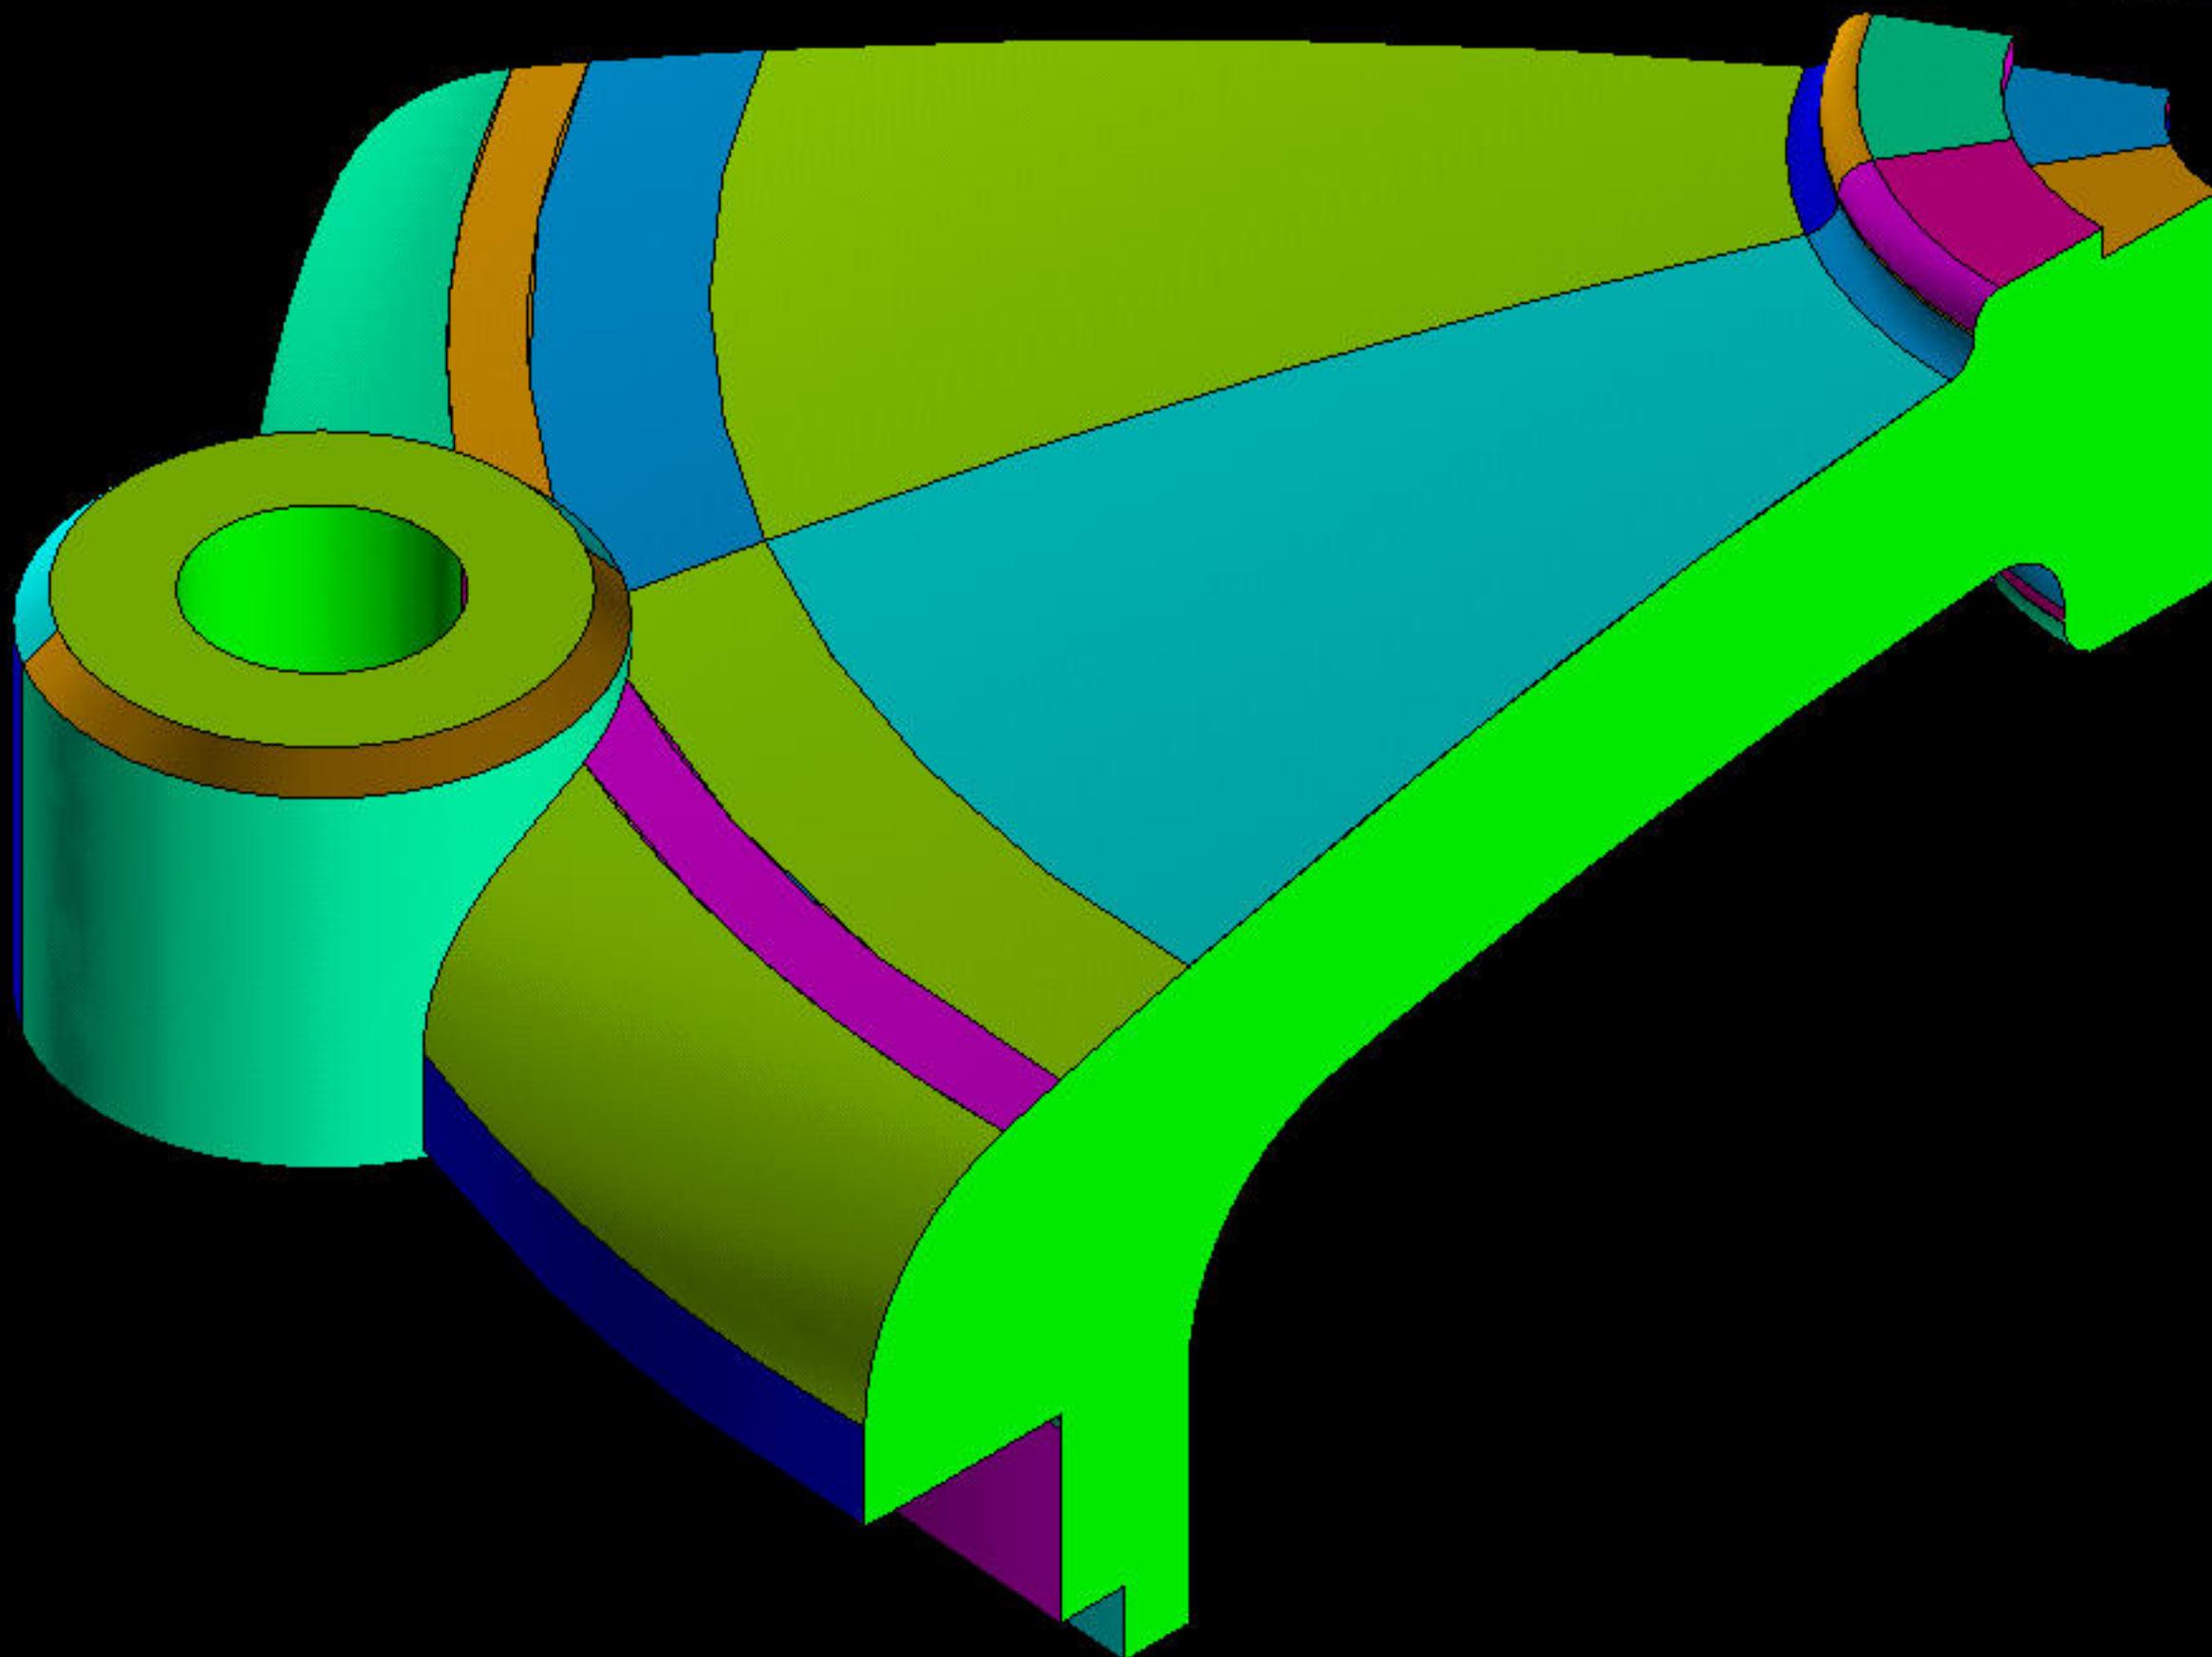
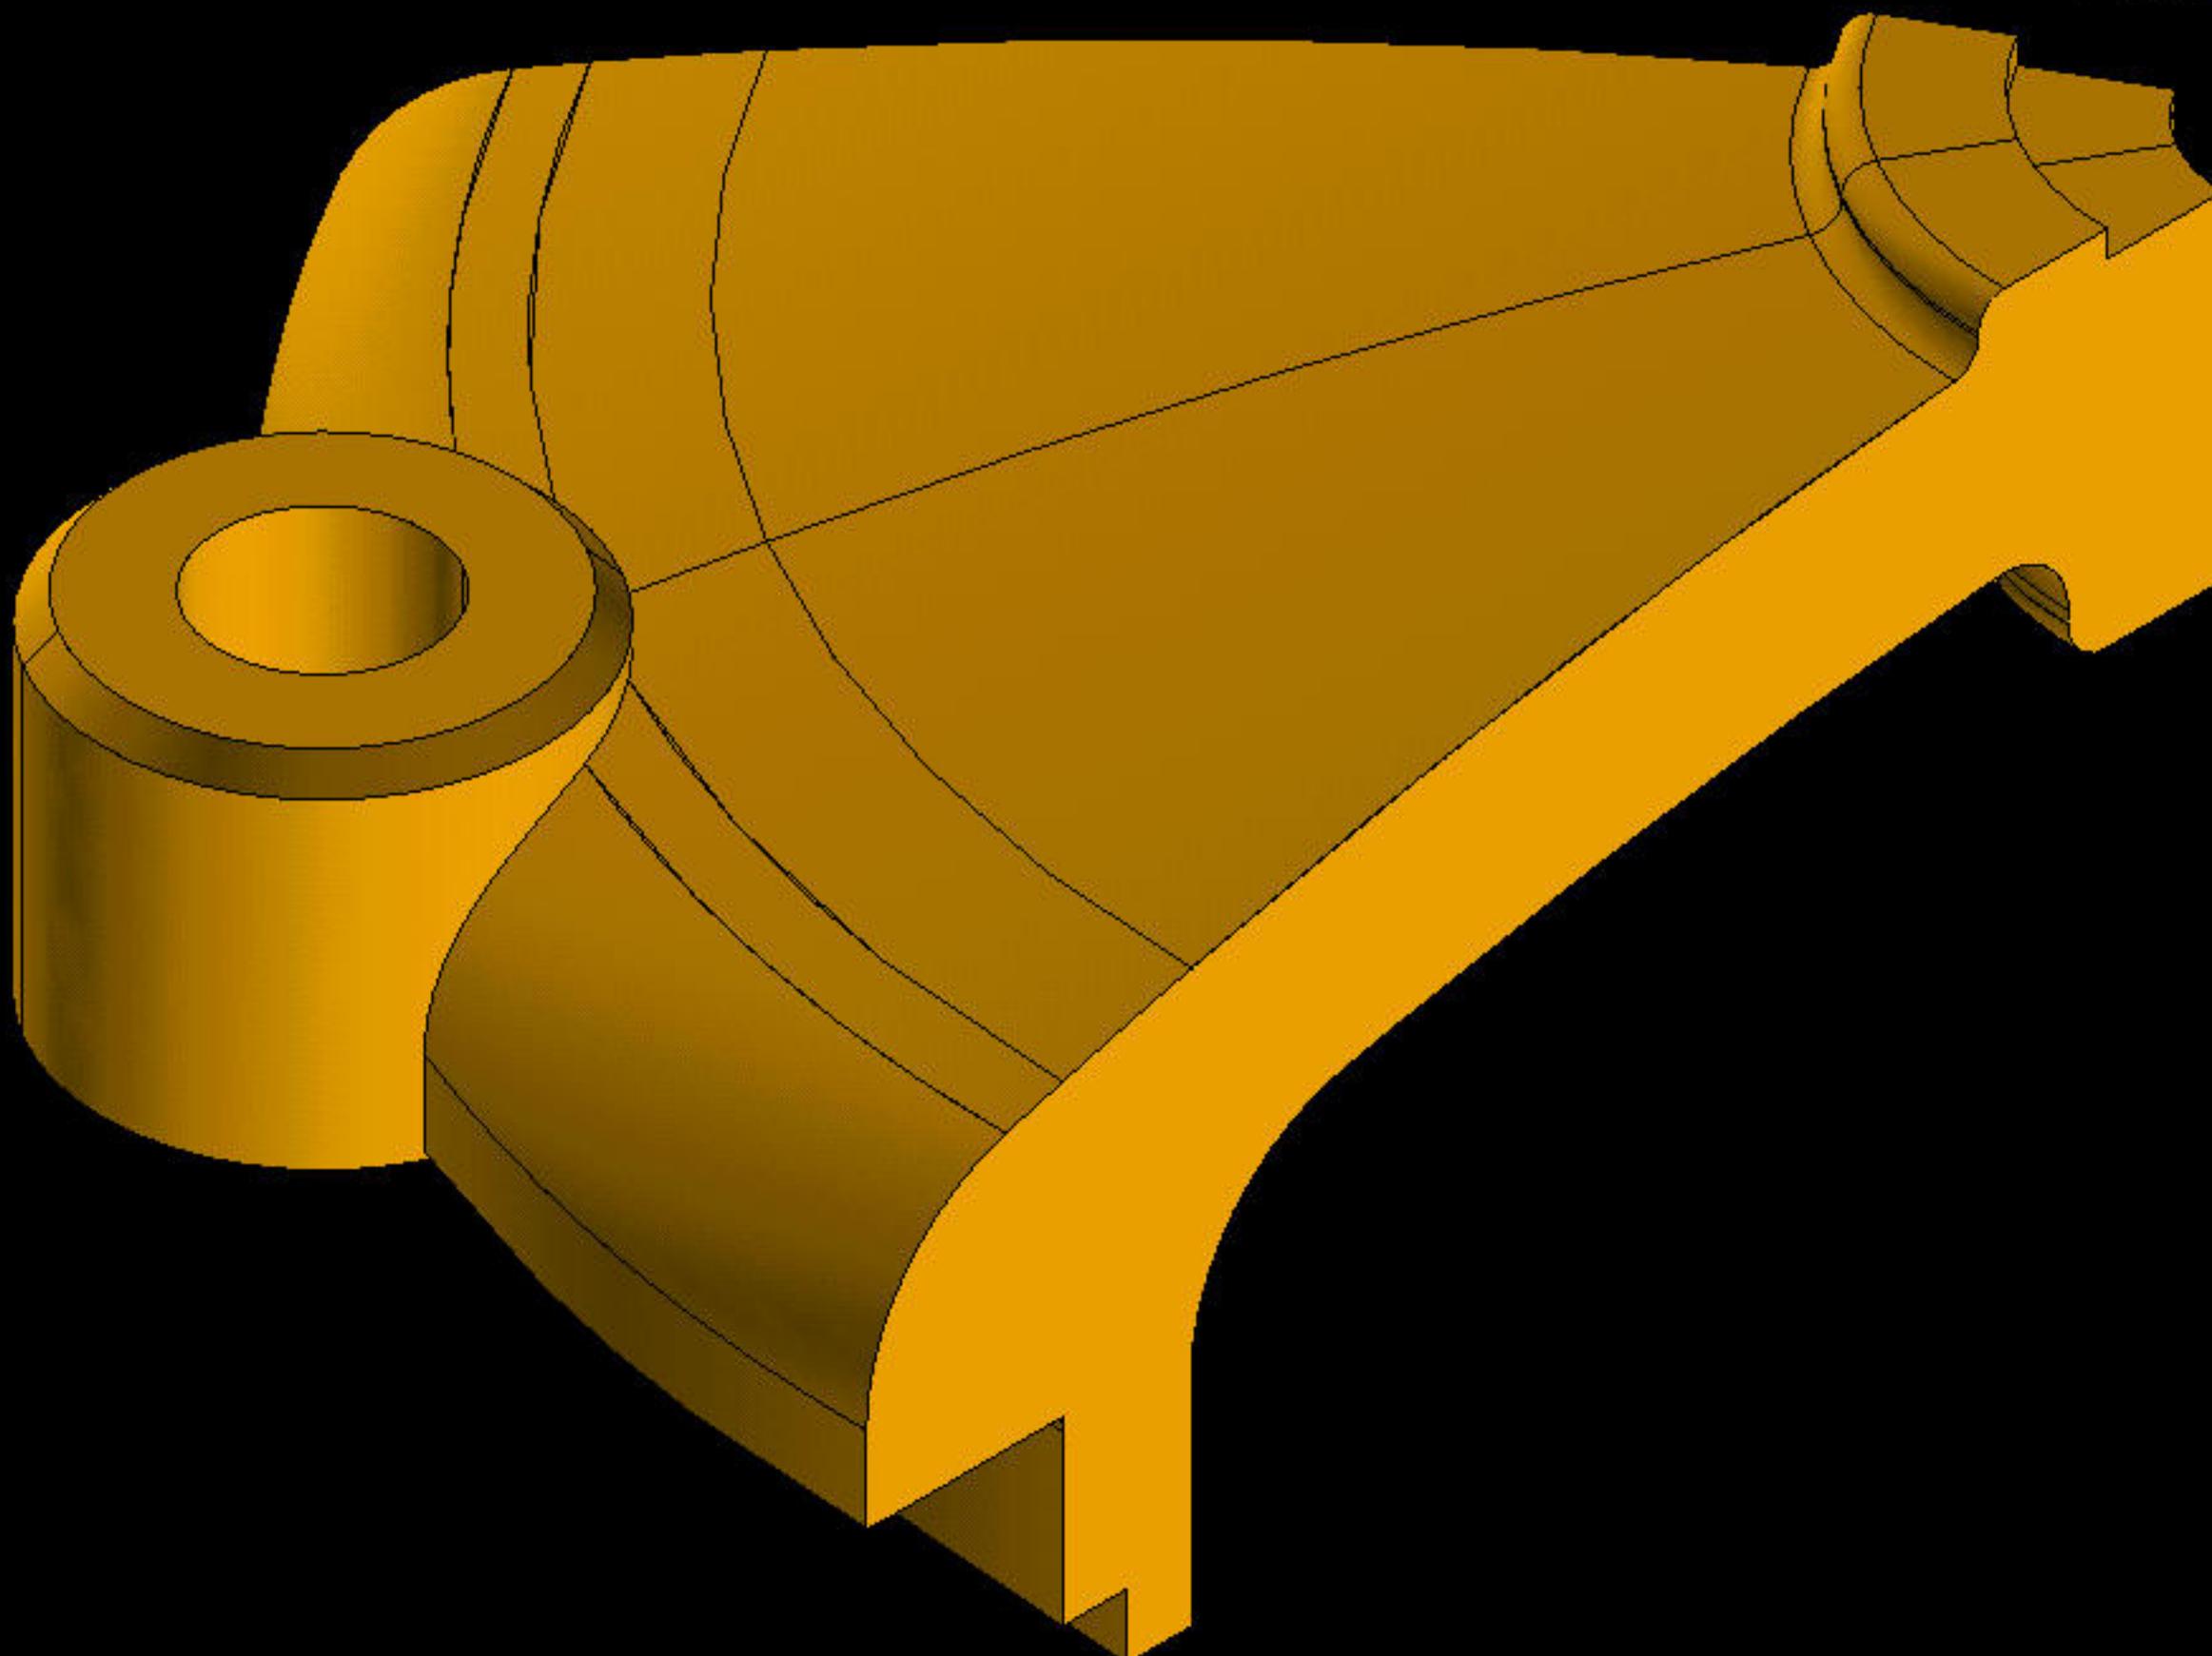
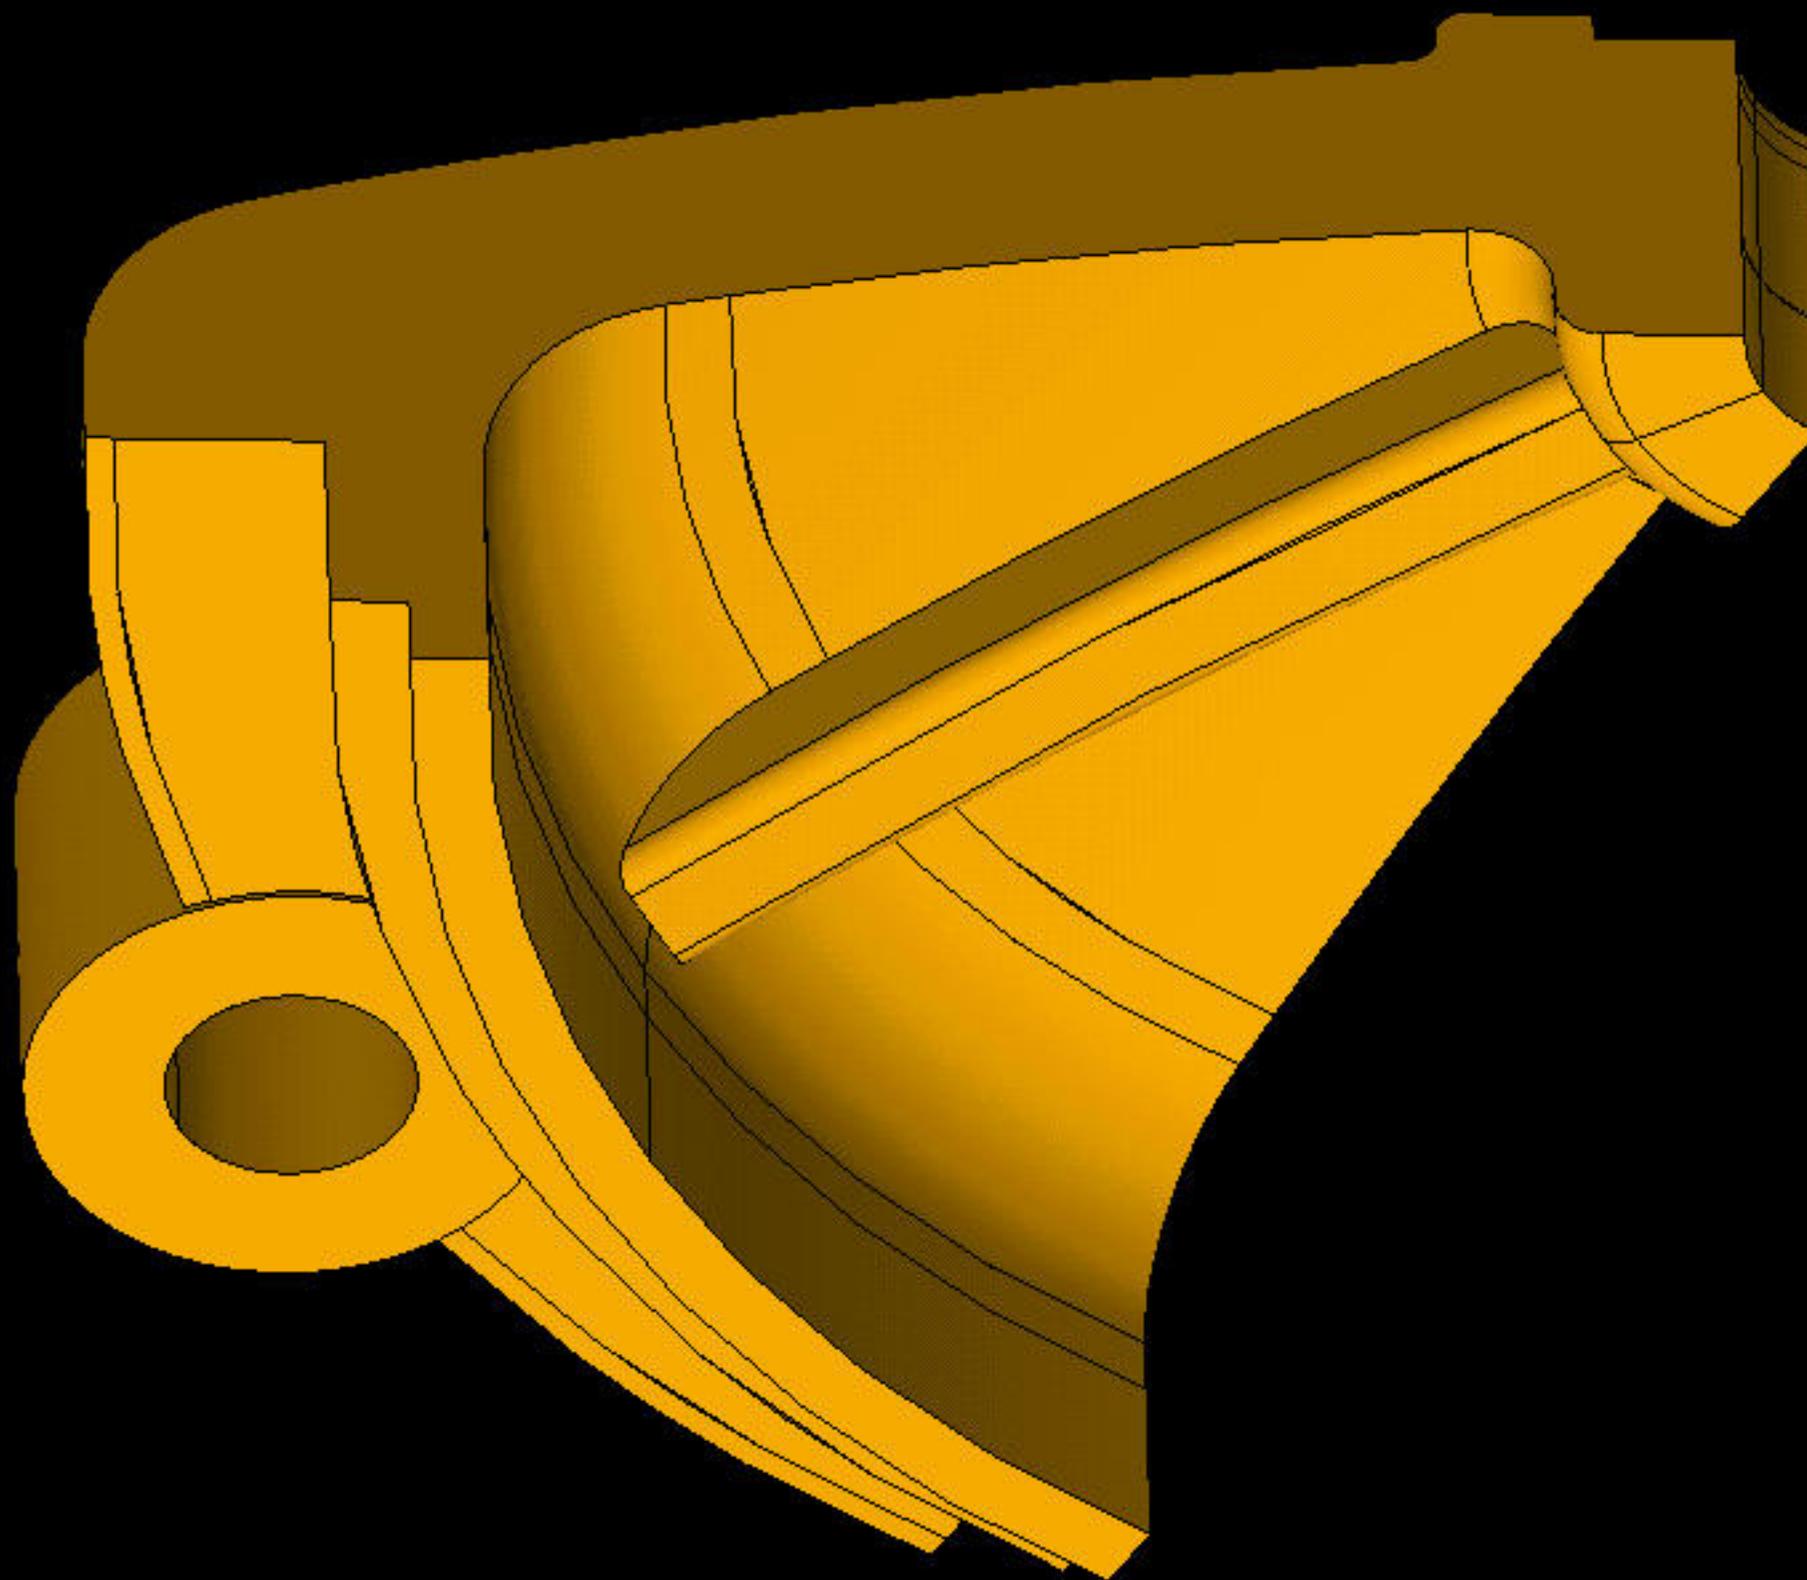
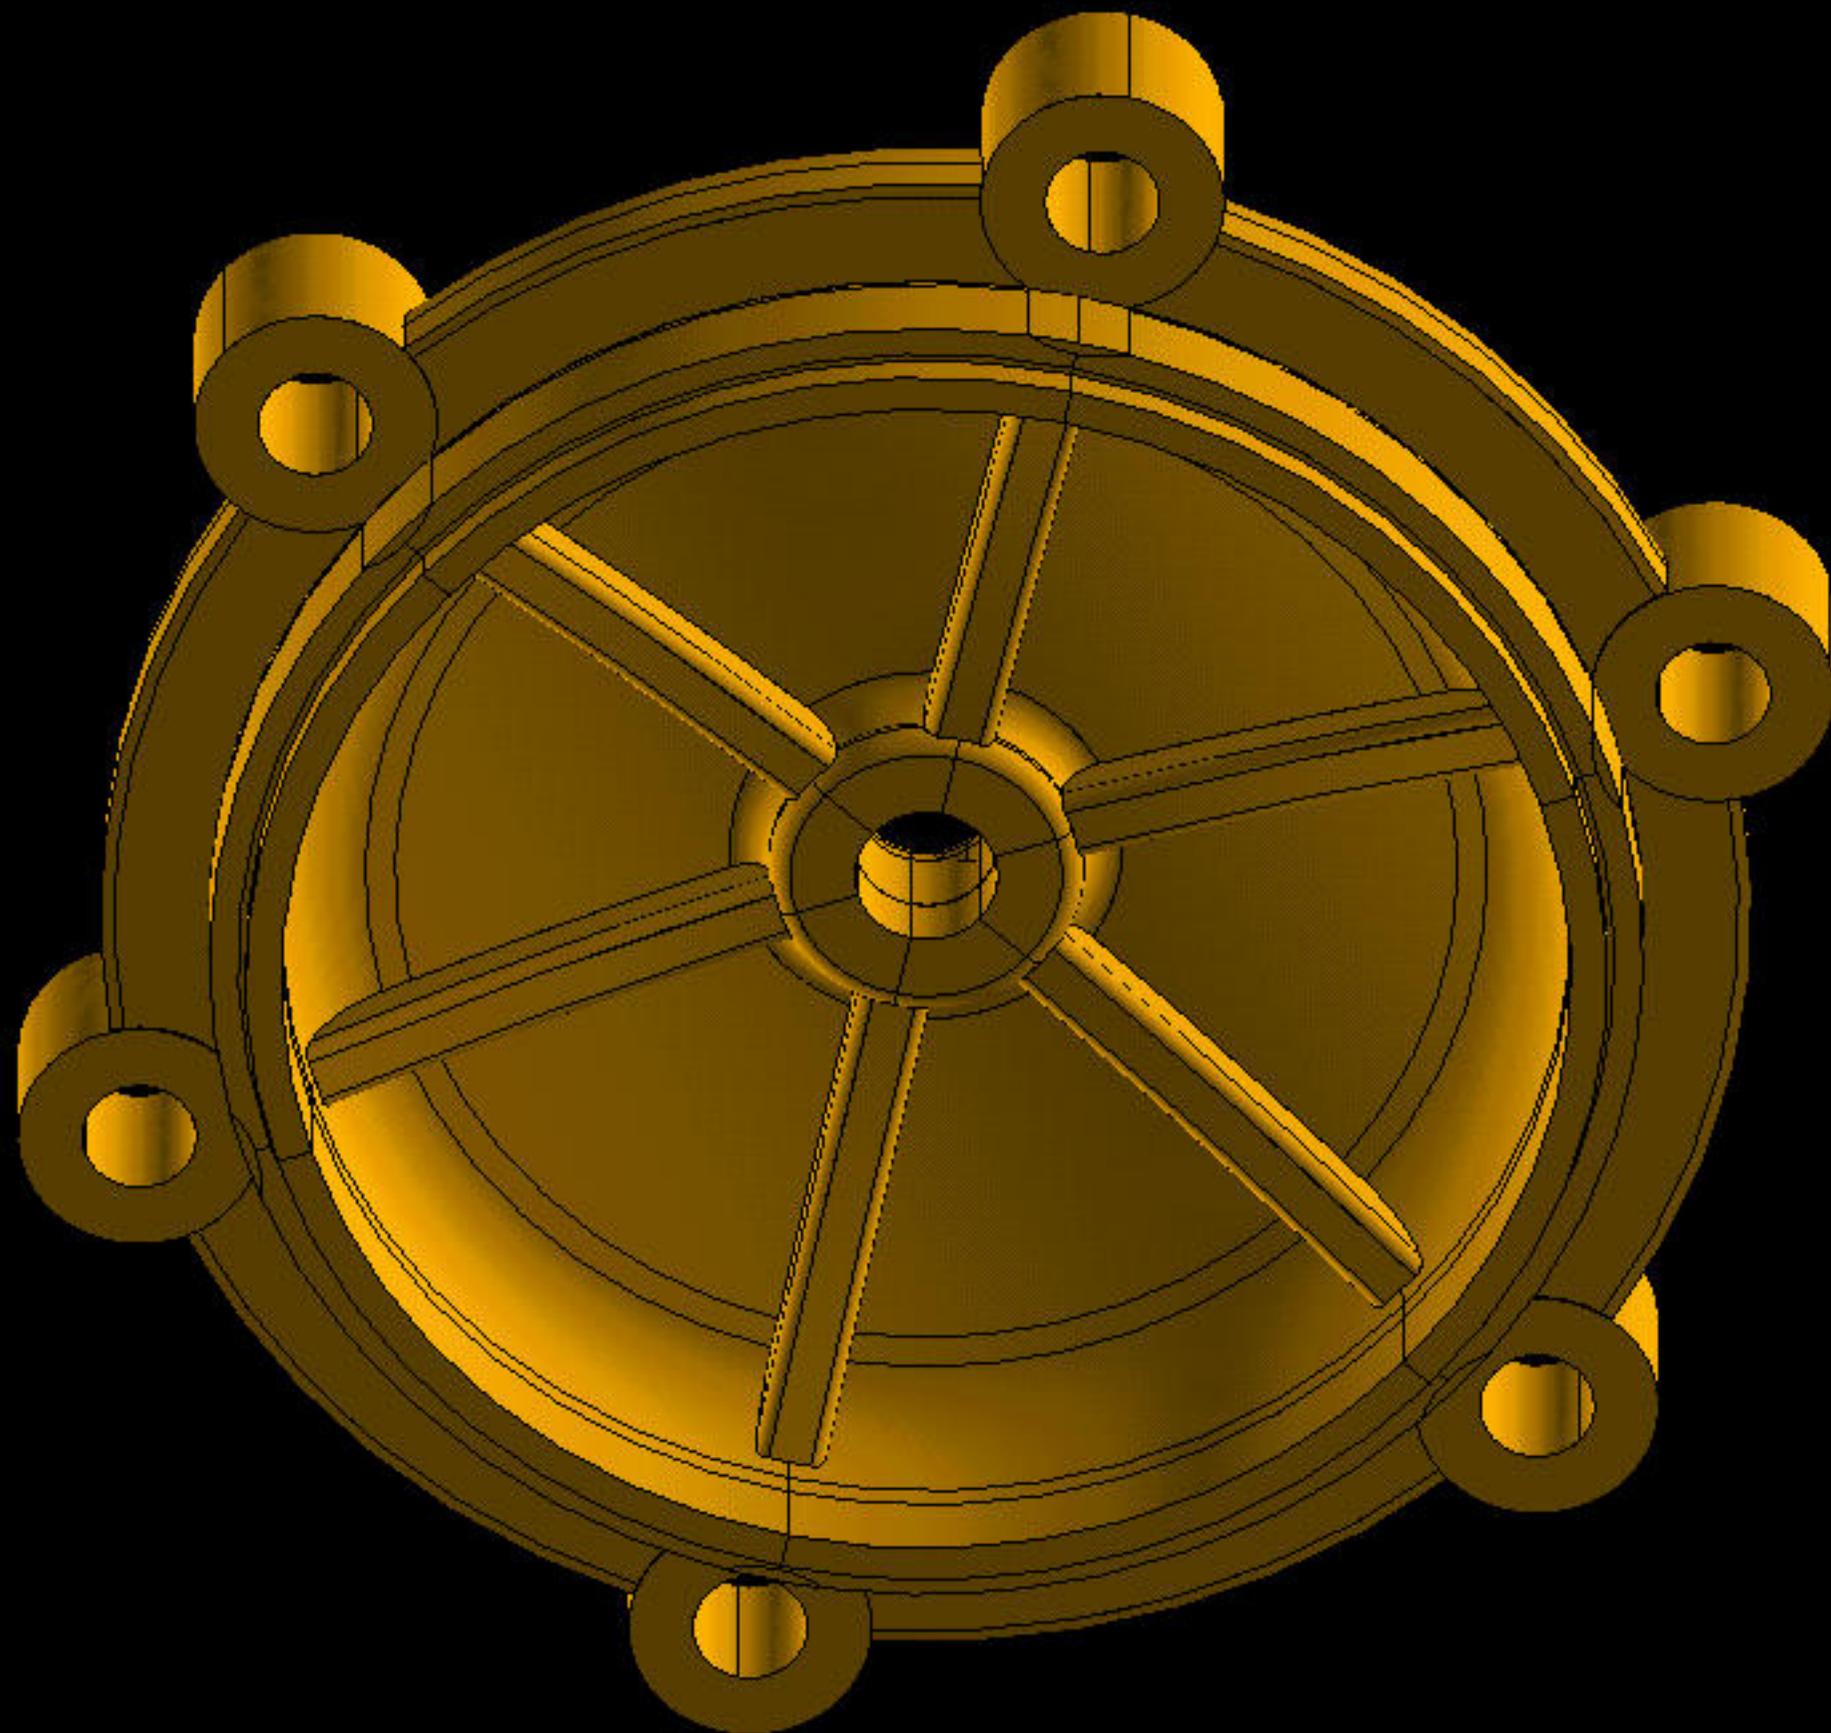
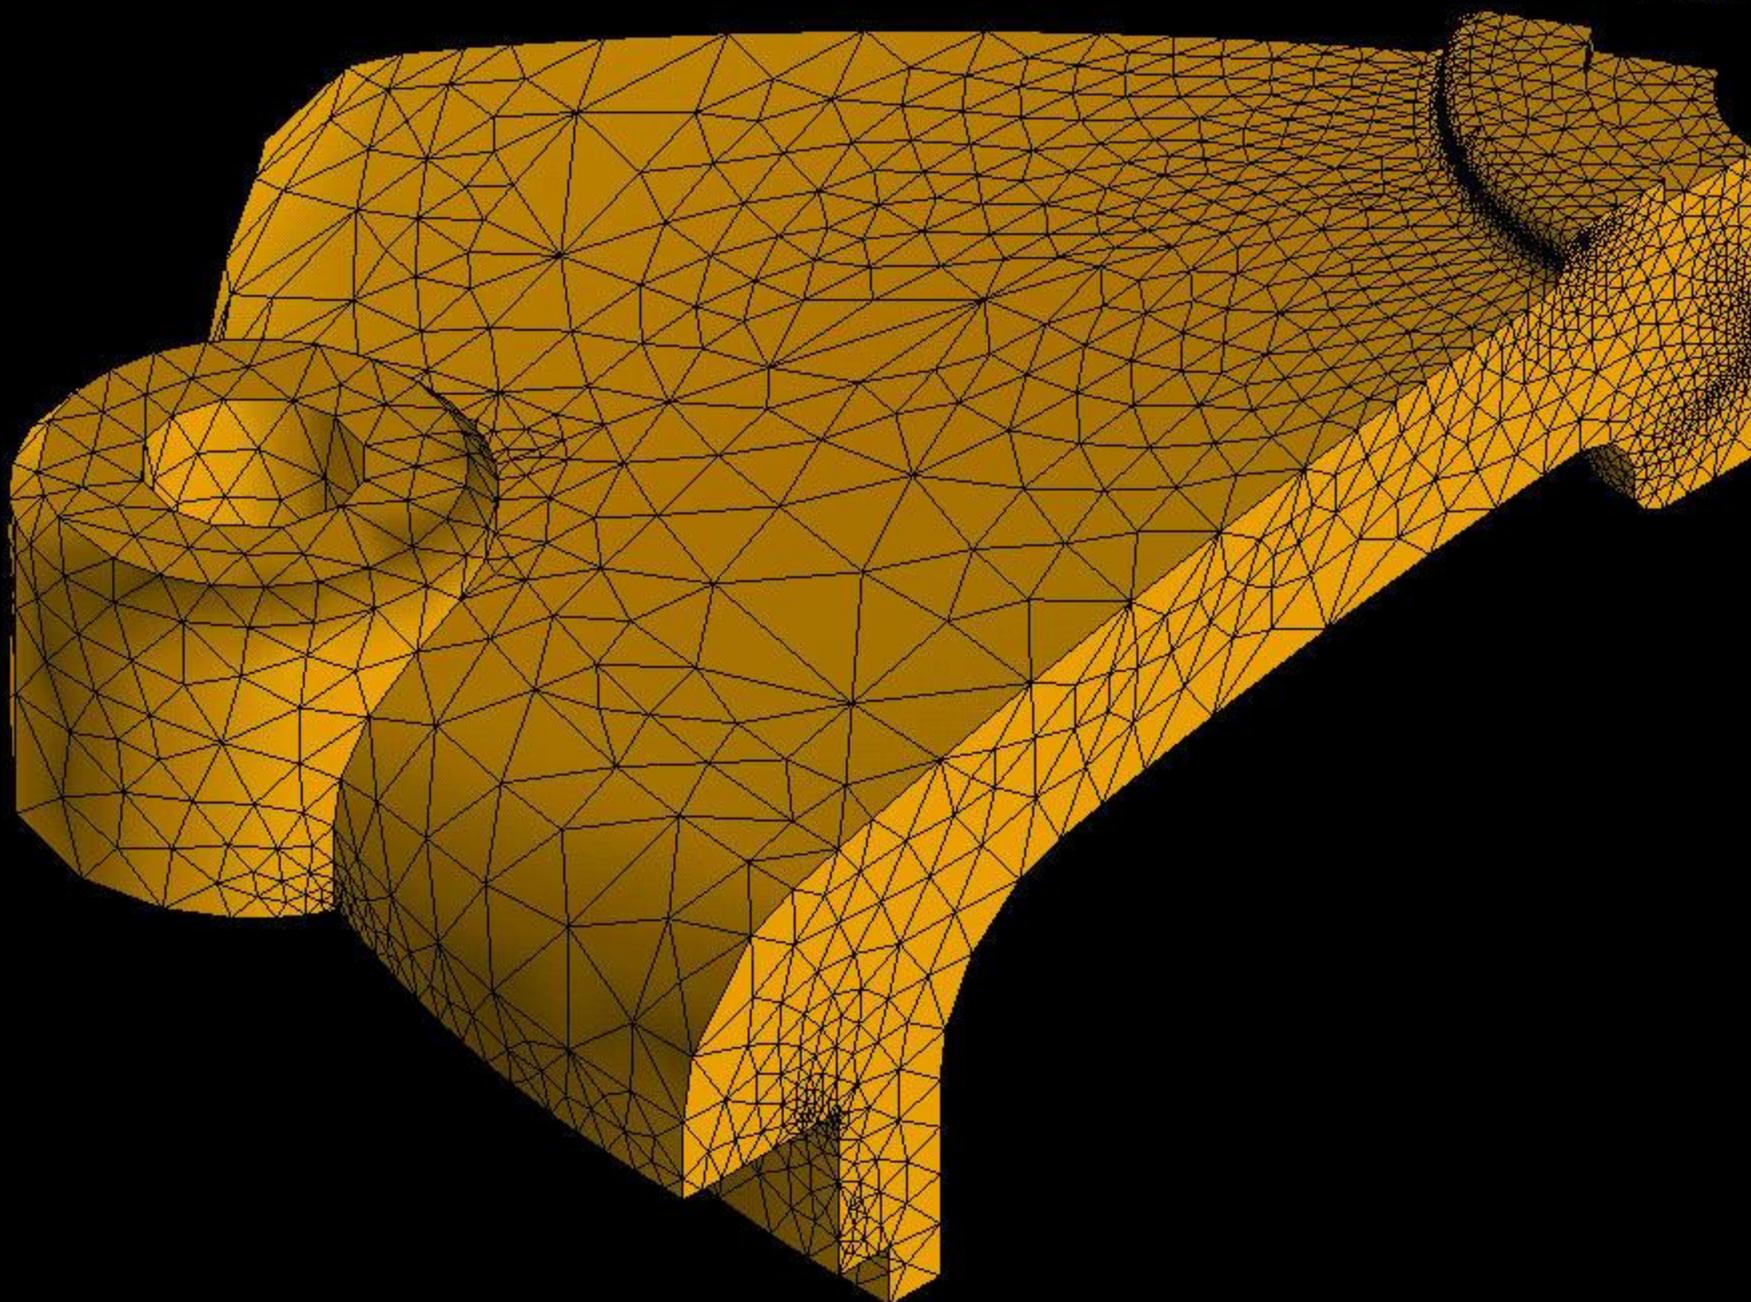
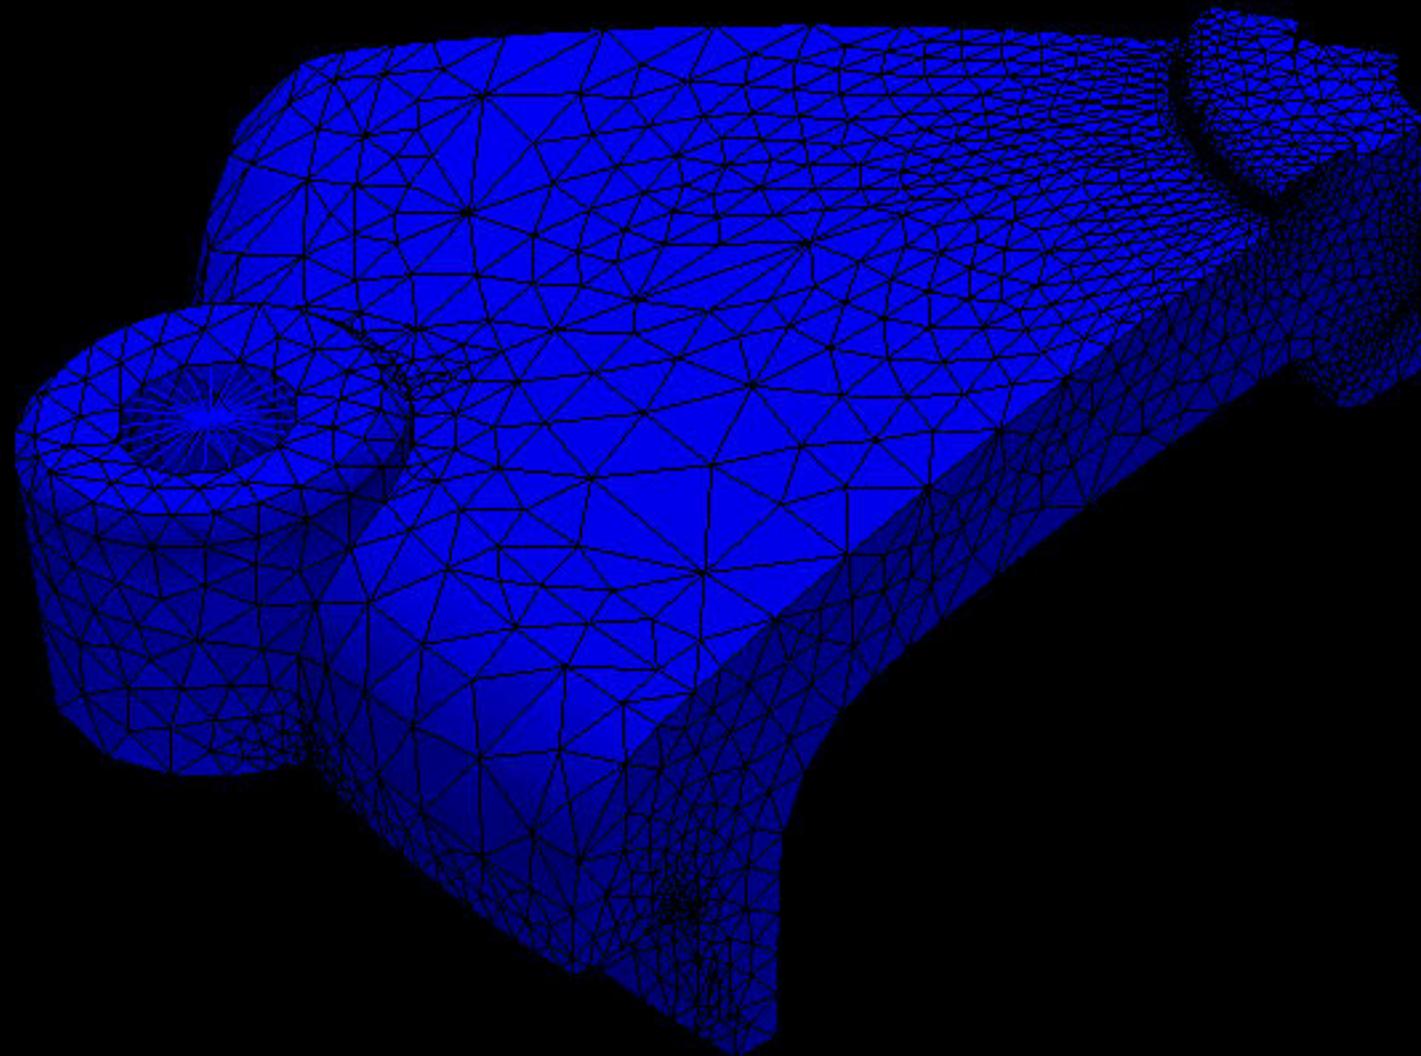
The exact material specification for the compressor cap was not known. Hence, the measured value of tensile strength was used for calculation purposes. From the results of the analysis, it was found that the stresses in the dished portion of the cap were well within allowable stress levels. However, the localized high stresses (beyond the measured tensile strength of the material) in the cast iron cap near the center jack bolt and the near the cap bolts located at the perimeter were causing the failure of the compressor cap.

The attached FEA plots show the model and results for one of the cases analyzed.

A re-design using cast steel (e.g. SA-216 Grade WCB or Grade WCC) with the current cap dimensions led to acceptable stress levels in the compressor cap. Based on the above analysis, it was recommended to replace the compressor cap material from cast iron to cast steel.
